NATIONAL TRANSPORTATION SAFETY BOARD

AIRCRAFT ACCIDENT REPORT

AIR FLORIDA, INC.
BOEING 737-222, N62AF
COLLISION WITH 14TH STREET BRIDGE,
NEAR WASHINGTON NATIONAL AIRPORT
WASHINGTON, D.C.
JANUARY 13, 1982

NTSB-AAR-82-8

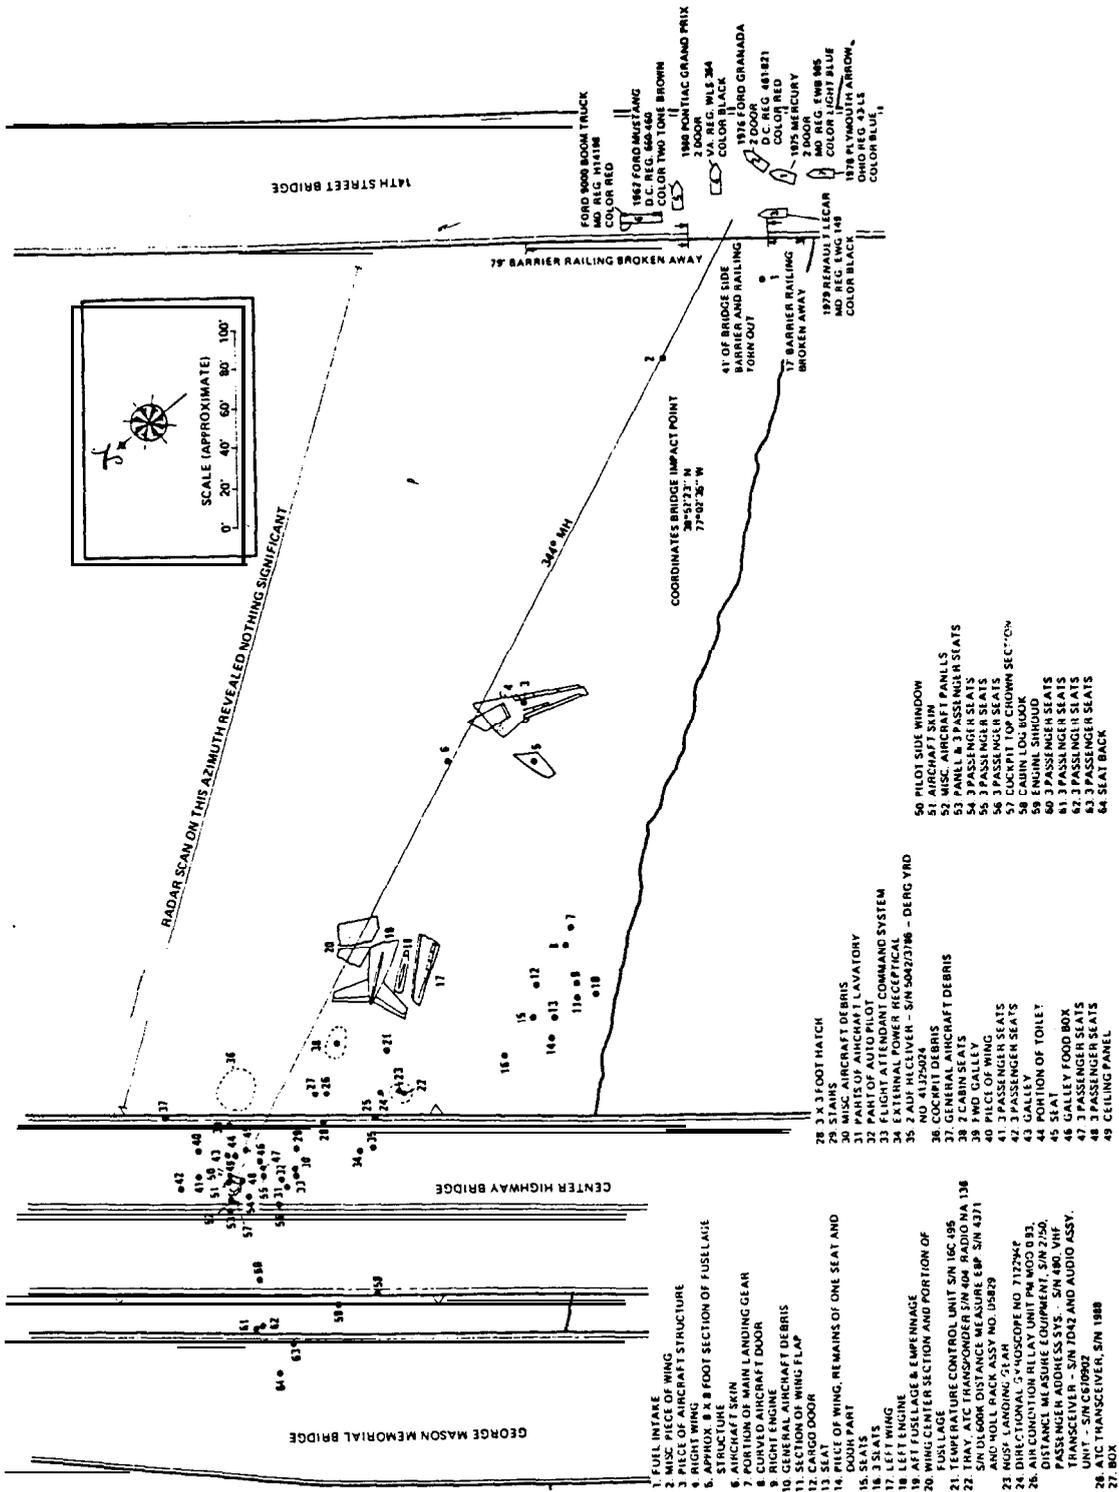
Figure 4. -- Position of Wreckage in the Water.

As the aircraft descended, the right wing was structurally damaged when it hit the boom truck, and shortly thereafter, the aircraft struck the steel barrier and railing on the west side of the 14th Street Bridge at an elevation of about 37 feet mean sea level. Fragments of the right wing remained on the bridge. The remainder of the wreckage sank in the Potomac River in about 25 to 30 feet of water. The wreckage area was confined to the south side of the river between the 14th Street Bridge and the Center Highway Bridge of the George Mason Memorial Bridge. (See figure 4.)

After initial impact, the aircraft broke into several major pieces. The fuselage broke into four major pieces which included: (1) nose section with cockpit; (2) fuselage section between nose section and wing center section; (3) fuselage-to-wing intersection; and (4) aft body structure with empennage attached. The wing structure was separated into three major pieces which included: (1) left wing outboard of the No. 1 engine, including all associated flight control surfaces; (2) wing center section, lower surface, including wing lower surface stubs between the No. 1 engine mounts and the No. 2 engine mounts; and (3) right wing outboard of the No. 2 engine with the outboard 20 feet mostly disintegrated. The left main landing gear was separated from the wing, and the right main gear remained attached except for the wheels and oleo piston. The nose landing gear and its attaching structure were separated from the nose section. Both engines and their pylon structures were separated from the wings. There was no evidence of fire on any of the recovered structure.

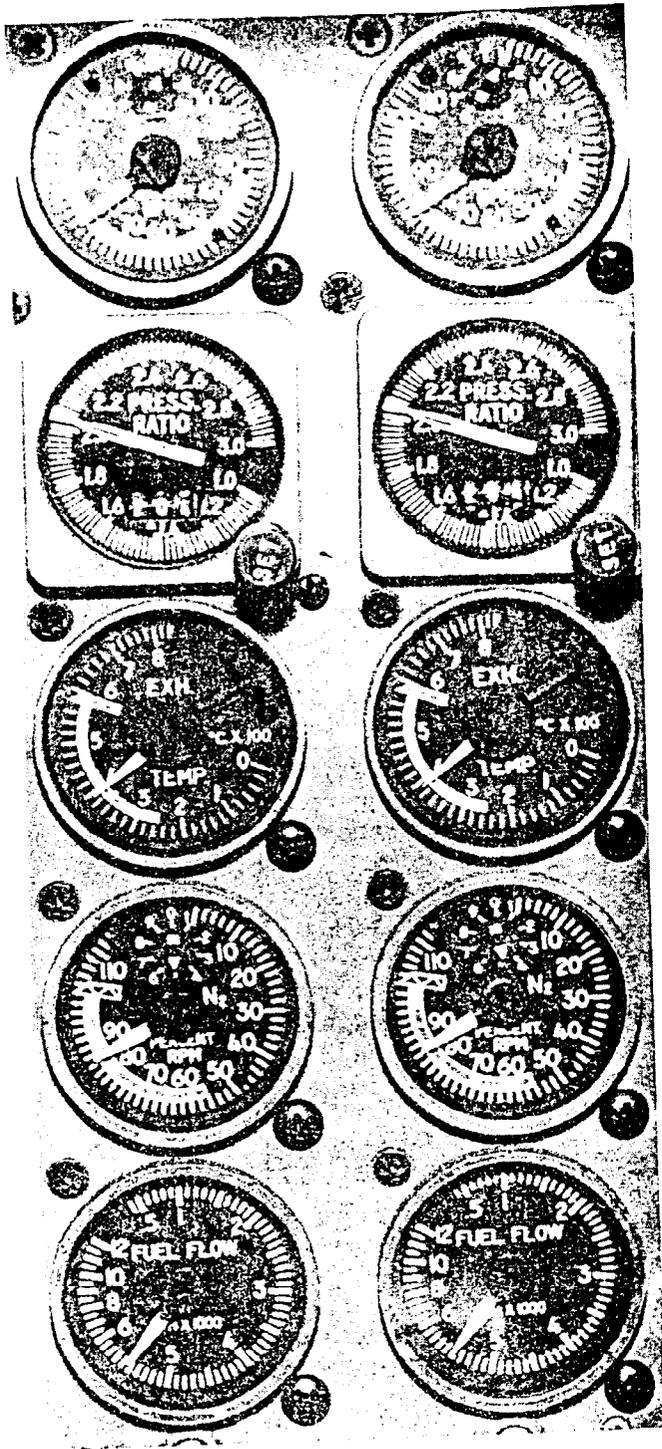
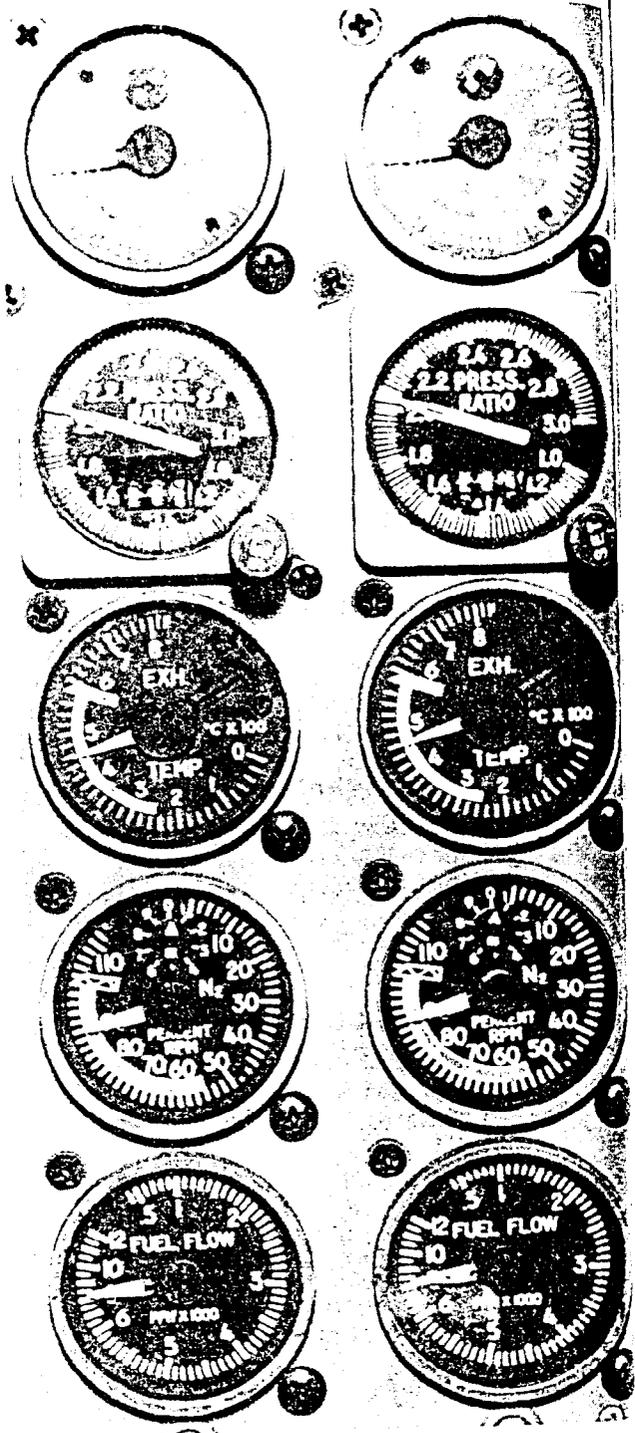
Figure 6.—Comparison of Instrument Readings -- 1.70 EPR vs. 2.04 EPR.

Engine Instrument Indication:
1.70 EPR P_{t2} probe blocked
Engine anti-ice-Off

Engine Instrument Indication:
2.04 EPR
Normal Operation

~~With the engine~~ operating, a false indication of the actual EPR can be indicated in the cockpit when ice blocks the inlet probe. Under this condition, the P_{t_2} probe is vented to the nose cone pressure through a siphon-break hole in the sense line. The interior of the engine nose cone is vented to the engine inlet static pressure, which is lower than the engine inlet total pressure normally sensed by the P_{t_2} system. Under severe icing conditions, if the engine inlet anti-icing air bleed system is shut off and the normal P_{t_2} sensing port is blocked with ice, the P_{t_2} sensor will sense the lower pressure at the vent port in the nose cone. The cockpit indication may become slightly erratic as icing begins to block the probe and will indicate a significantly higher reading when ice fully blocks the probe. Tests have demonstrated that with a blocked probe at takeoff, engine power can indicate an EPR of about 2.04 with the engine actually operating at an EPR ratio of 1.70. Under these circumstances, a pilot would unknowingly attempt takeoff at a considerably lower thrust than desired. However, the pilot has available other indications of engine operation displayed in the cockpit, such as a lower N_1 , N_2 , EGT, and F/F consistent with the reduced engine thrust. (See figure 6.)

Should the pilot activate the engine inlet anti-icing system with a blocked probe, he would immediately notice a substantial drop in the indicated EPR, incorrectly indicating a low engine thrust as long as the normal P_{t_2} sensing port remains blocked. This results from the introduction of engine anti-icing air flow into the nose cone and resultant increase in the pressure in the interior of the nose cone. This pressure is higher than that which would be sensed at the normal P_{t_2} port. Falsely low indicated EPR's have been detected by pilots when they found that they were unable to set takeoff power without exceeding redline N_1 , N_2 , and EGT.
