NATIONAL TRANSPORTATION SAFETY BOARD

AIRCRAFT ACCIDENT REPORT

AIR FLORIDA, INC.
BOEING 737-222, N62AF
COLLISION WITH 14TH STREET BRIDGE,
NEAR WASHINGTON NATIONAL AIRPORT
WASHINGTON, D.C.
JANUARY 13, 1982

NTSB-AAR-82-8

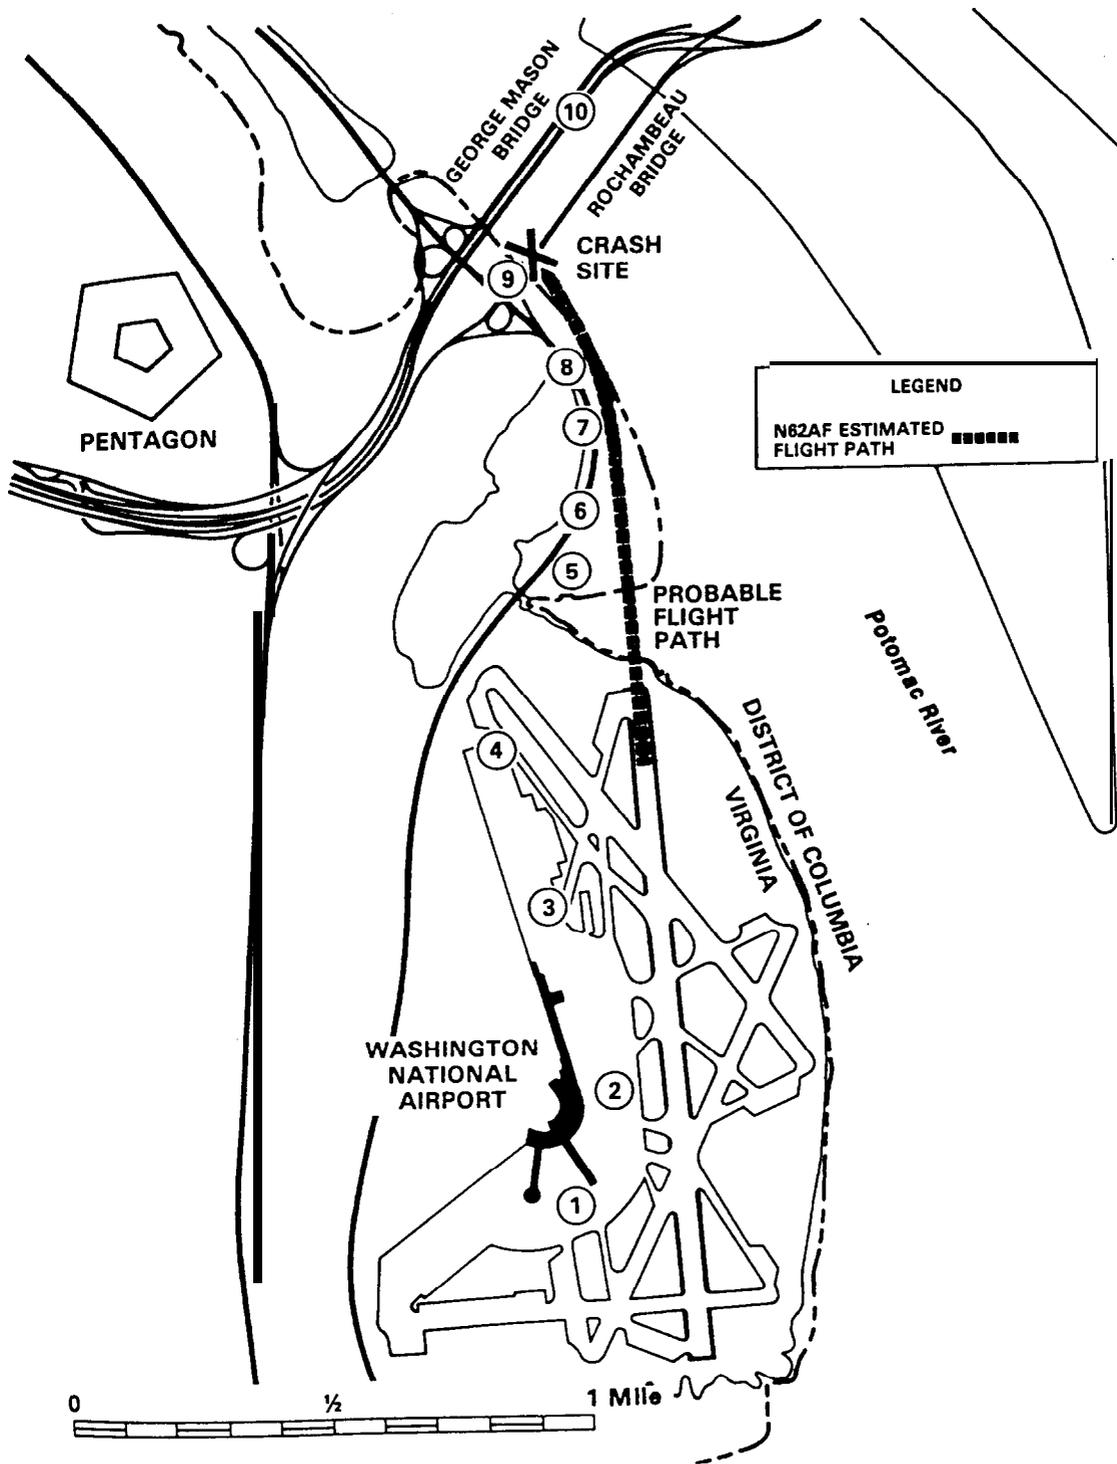
Figure 1.-Flightpath and witness locations.

Safety Board investigators interviewed more than 200 witnesses to establish the sequence of events from the start of the takeoff until impact, and more than 10 written statements were obtained. (See figure 1 for witness locations and flightpath. Numbers correlate to the locations of 10 of the witnesses interviewed.)

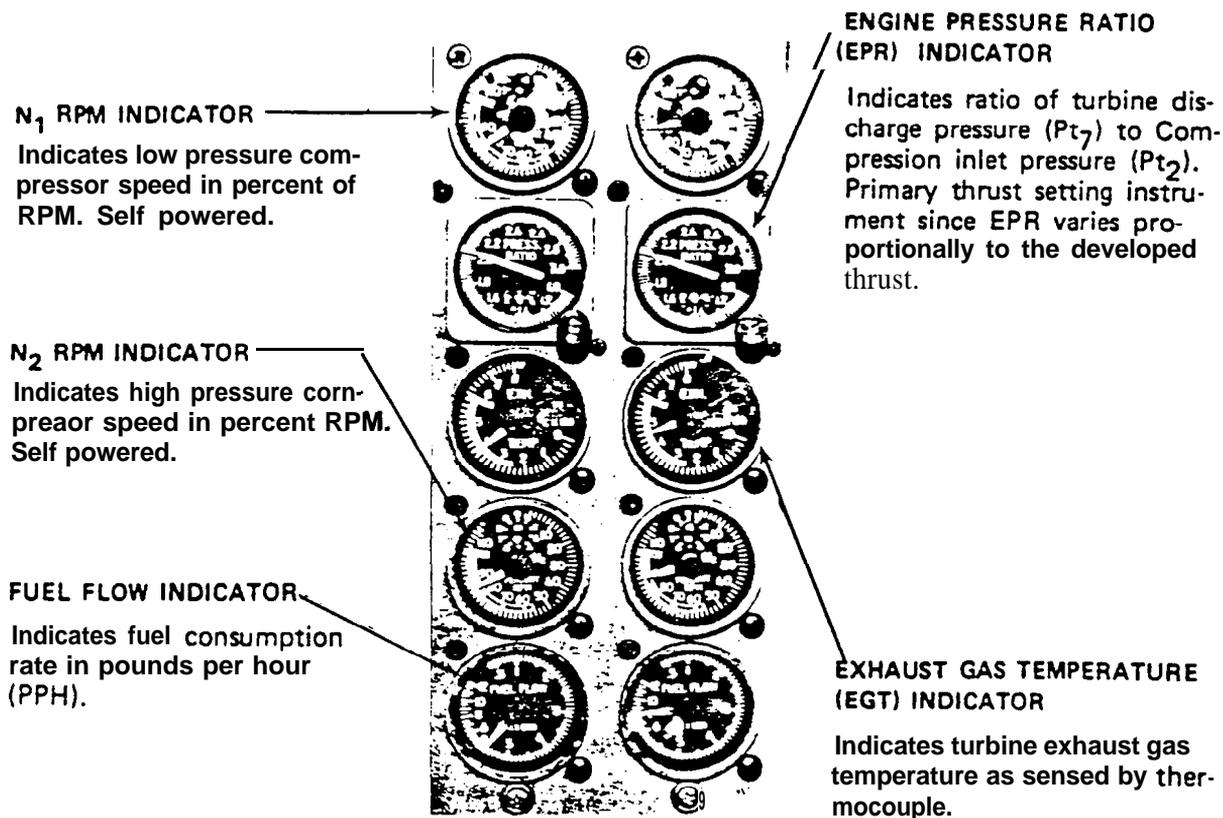
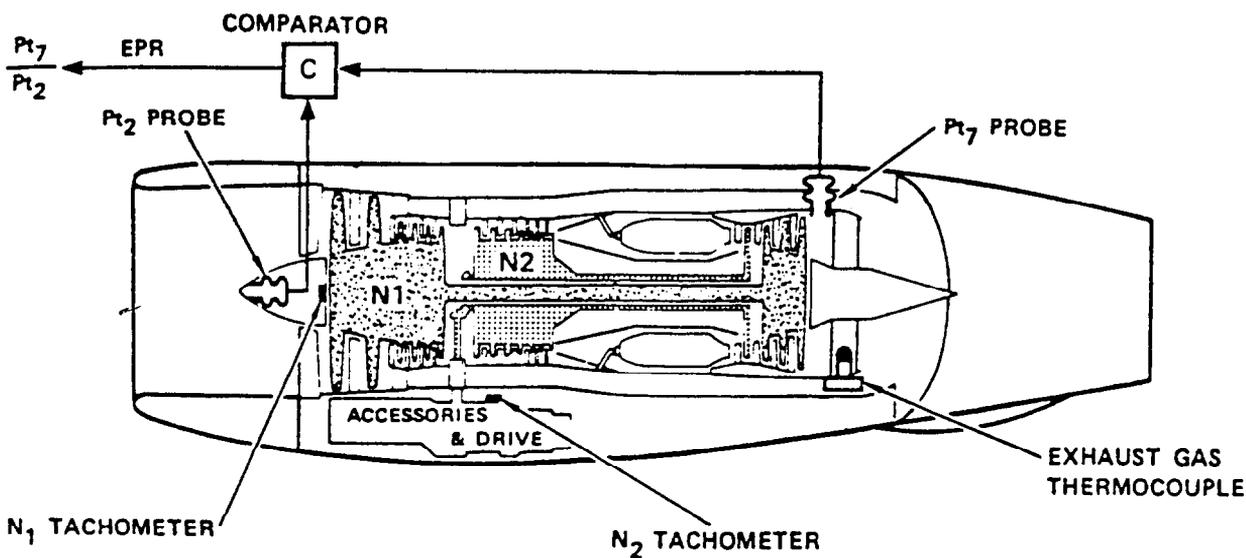
Figure 5. -- Center instrument panel functions.

The B-737's primary engine instrumentation consists of: engine pressure ratio (EPR), a direct indication of the ratio of the pressure measured at the turbine discharge pressure (Pt₇) to the pressure measured at the compressor inlet (Pt₂); the first stage fan or low pressure compressor speed (N₁); the high pressure compressor speed (N₂); the exhaust gas temperature (EGT); and the fuel flow (F/F). (See figure 5.)

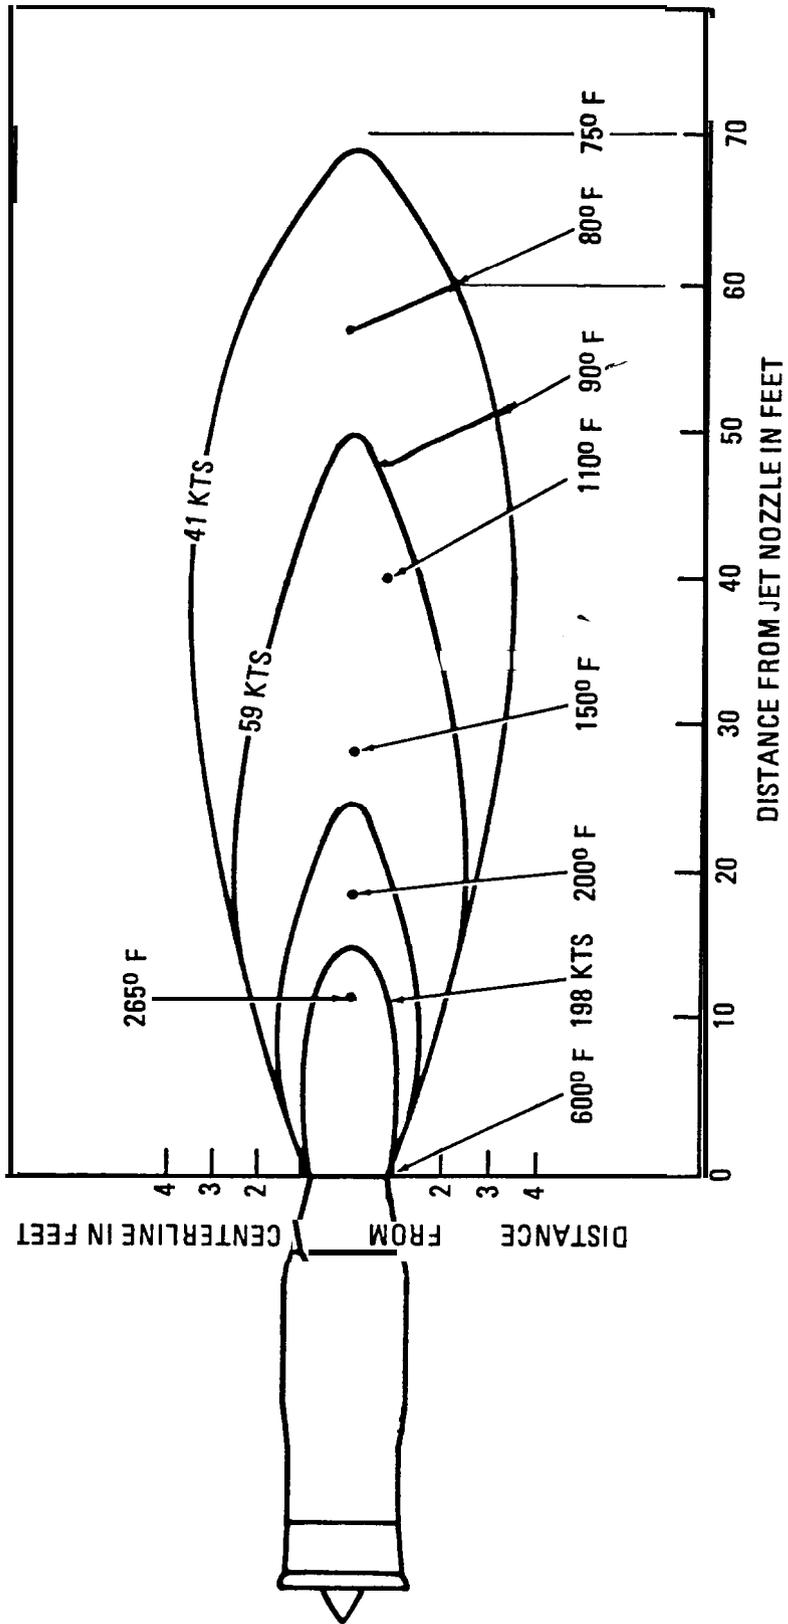
Figure 7.--JT8D turbofan exhaust gas temperatures and velocities.

Jet exhaust temperatures and velocities at given distances and power setting behind the exhaust nozzles of JT8D turbofan engines were determined to provide an indication of their effects on following aircraft. (See figure 7.)
